Lake Metonga

Forest County, Wisconsin

Comprehensive Management Plan

March 2021

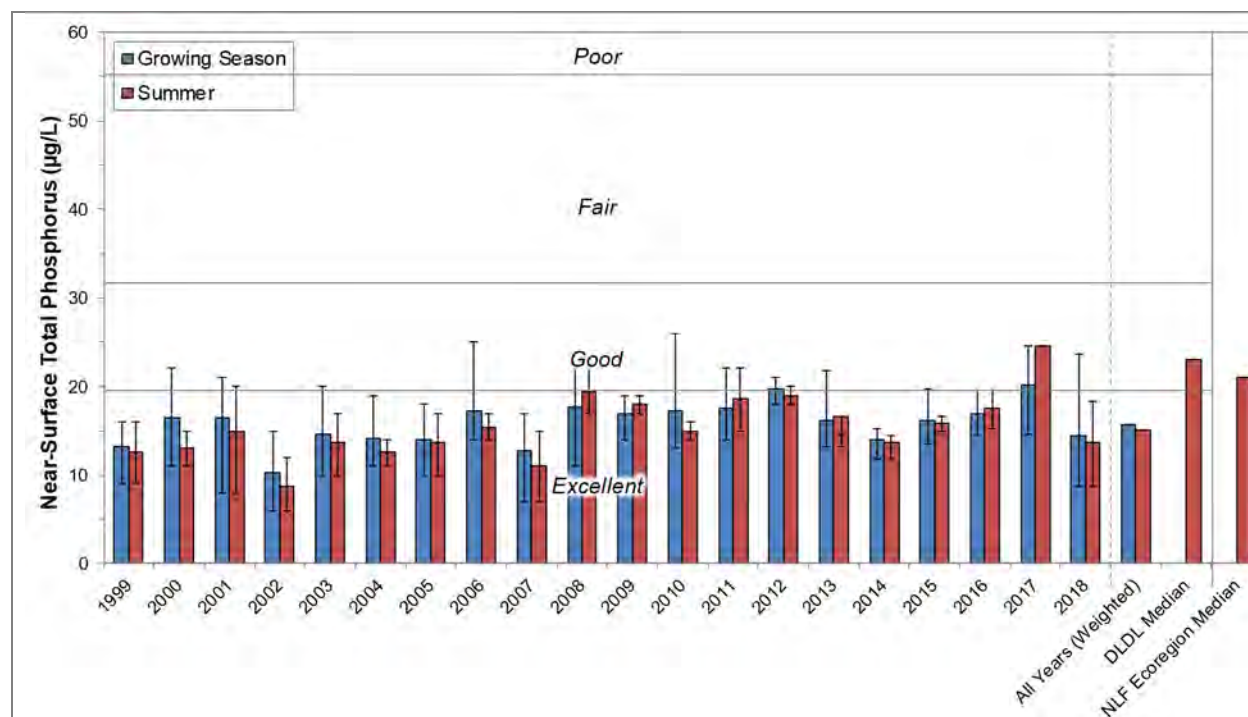
Figure 3.1-3. Lake Metonga, state-wide class 5 lakes, and regional total phosphorus concentrations. Mean values calculated with summer month surface sample data. Water Quality Index values adapted from WDNR PUB WT-913.

Lake Metonga has a long record of water quality data with Secchi disc depth being available from 1992 through 2018 while total phosphorus and chlorophyll-*a* data is available for 1999-2018. The summer mean total phosphorus (TP) is 15.0 $\mu\text{g/L}$ (Figure 3.1-3) and the growing season mean concentration is nearly the same at 15.7 $\mu\text{g/L}$. Both of these averages fall within the *excellent* category and are better than the Northern Lakes and Forests ecoregion (NLF) median value and the median value for lakes of this type in the state.

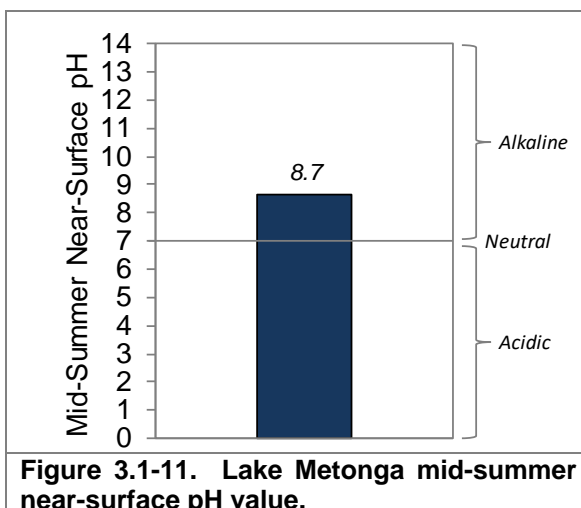
The pH scale ranges from 0 to 14 and indicates the concentration of hydrogen ions (H^+) within the lake's water and is an index of the lake's acidity. Water with a pH value of 7 has equal amounts of hydrogen ions and hydroxide ions (OH^-), and is considered to be neutral. Water with a pH of less than 7 has higher concentrations of hydrogen ions and is considered to be acidic, while values greater than 7 have lower hydrogen ion concentrations and are considered basic or alkaline. The pH scale is logarithmic; meaning that for every 1.0 pH unit the hydrogen ion concentration changes tenfold. The normal range for lake water pH in Wisconsin is about 5.2 to 8.4, though values lower than 5.2 can be observed in some acid bog lakes and higher than 8.4 in some marl lakes. In lakes with a pH of 6.5 and lower, the spawning of certain fish species such as walleye becomes inhibited (Shaw and Nimphius 1985). The mid-summer pH of the water in Lake Metonga was found to be 8.7 which is at the upper range of the normal range for Wisconsin Lakes but it is not a concern (Figure 3.1-11).

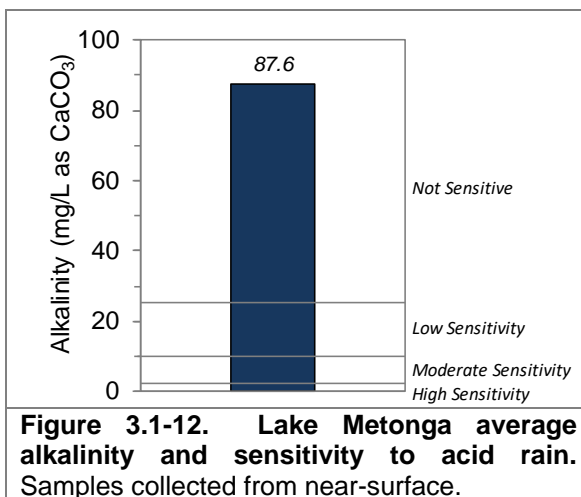
Alkalinity is a lake's capacity to resist fluctuations in pH by neutralizing or buffering against inputs such as acid rain. The main compounds that contribute to a lake's alkalinity in Wisconsin are bicarbonate (HCO_3^-) and carbonate (CO_3^{2-}), which neutralize hydrogen ions from acidic inputs. These compounds are present in a lake if the groundwater entering it comes into contact with minerals such as calcite ($CaCO_3$) and/or dolomite ($CaMgCO_3$). A lake's pH is primarily determined by the amount of alkalinity. Rainwater in northern Wisconsin is slightly acidic naturally due to dissolved carbon dioxide from the atmosphere with a pH of around 5.0. Consequently, lakes with low alkalinity have lower pH due to their inability to buffer against acid inputs. The alkalinity in Lake Metonga was measured at 89.5 (mg/L as $CaCO_3$), indicating that the lake has a substantial capacity to resist fluctuations in pH and has a low sensitivity to acid rain (Figure 3.1-12).

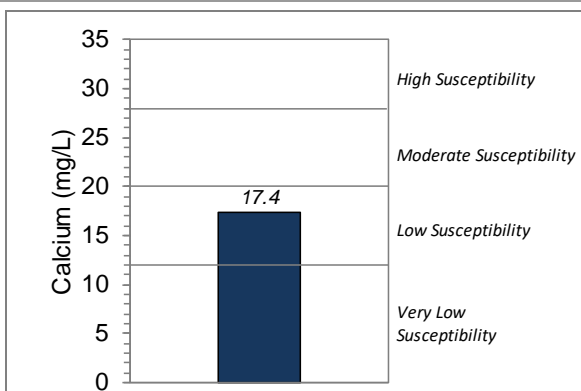
Figure 3.1-13. Lake Metonga spring calcium concentration and zebra mussel susceptibility. Samples collected from near-surface.

Like associated pH and alkalinity, the concentration of calcium within a lake's water depends on the geology of the lake's watershed. Recently, the combination of calcium concentration and pH has been used to determine what lakes can support zebra mussel populations if they are introduced. The commonly accepted pH range for zebra mussels is 7.0 to 9.0, so Lake Metonga's pH of 8.6 falls within this range. Lakes with calcium concentrations of less than 12 mg/L are considered to have very low susceptibility to zebra mussel establishment. The calcium concentration of Lake Metonga was found to be 17.4 mg/L, falling within the low susceptibility range for zebra mussels although as noted below, Lake Metonga has an established population of zebra mussels (Figure 3.1-13).

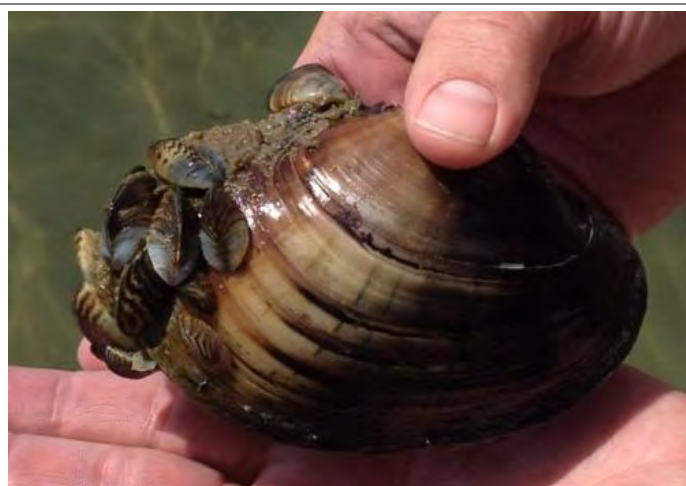
Zebra mussels (*Dreissena polymorpha*) are a small bottom-dwelling mussels, native to Europe and Asia, that found their way to the Great Lakes region in the mid-1980s. They are thought to have come into the region through ballast water of ocean-going ships entering the Great Lakes, and they have the capacity to spread rapidly. Zebra mussels can attach themselves to boats, boat lifts, and docks, and can live for up to five days after being taken out of the water. These mussels can be identified by their small size, D-shaped shell and yellow-brown striped coloring (Photograph 3.1-1). Once zebra

Photograph 3.1-1. Zebra mussels attached to a native mussel. Photo credit: Onterra.

Lake Metonga contains an established population of zebra mussels. Michael Preul, Mole Lake Sokaogon Chippewa Community fisheries biologists is currently monitoring five zebra mussel samplers from Lake Metonga, as well as various chemical and biological parameters from the lake. This includes understanding changes in calcium levels within the lake, perhaps in response to zebra mussel populations. Changes in calcium concentrations, potentially as it is being used by zebra mussels, may have a controlling factor on the maximum zebra mussel biomass within the lake (Whittier et al. 2008).

Preliminary accounts from the work being conducted by the Mole Lake Tribe indicate that the zebra mussel population within Lake Metonga is stabilizing, with anticipated population changes on an approximate 2-3 year cycle. Zebra mussels in recent years have been noted as smaller in size and having softer shells.

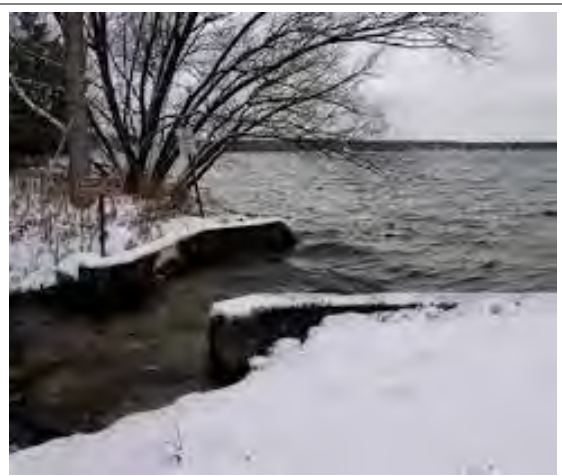
Lake Metonga has a concrete dam located on the south end of the lake which rebuilt in 1969 and was fixed at a level (weir of 99.42) that could artificially increase the lake's water level up to four feet (LMA 2002a). During drought years, such as the late-2000s, insufficient groundwater was present to hold the lake at this level. Outlet Creek, Lake Metonga's outlet, leads to the Swamp Creek which flows through Rice Lake on its way to the Wolf River.

Photograph 3.2-1. Lake Metonga dam.
Photo courtesy LMA.

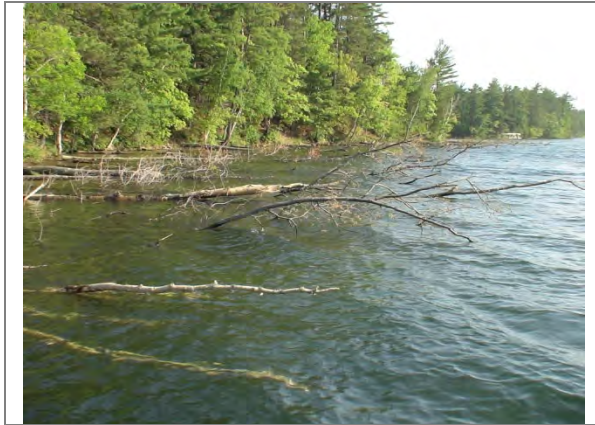
Emerging research in Wisconsin has shown that coarse woody habitat (sometimes called “coarse woody debris”), often stemming from natural or undeveloped shorelands, provides many ecosystem benefits in a lake. Coarse woody habitat describes habitat consisting of trees, limbs, branches, roots and wood fragments at least four inches in diameter that enter a lake by natural or human means. Coarse woody habitat provides shoreland erosion control, a carbon source for the lake, prevents suspension of sediments and provides a surface for algal growth which is important for aquatic macroinvertebrates (Sass 2009). While it impacts these aspects considerably, one of the greatest benefits coarse woody habitat provides is habitat for fish species.

Photograph 3.3-1. Example of coarse woody habitat in a lake.

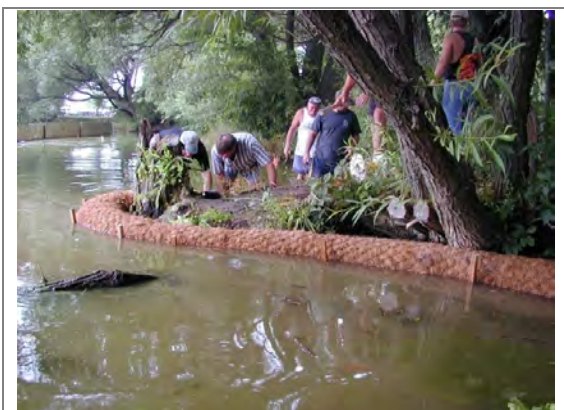
Photograph 3.3-2. Example of a biolog restoration site.

In recent years, many lakefront property owners have realized increased aesthetics, fisheries, property values, and water quality by restoring portions of their shoreland to mimic its unaltered state. An area of shore restored to its natural condition, both in the water and on shore, is commonly called a shoreland buffer zone. The shoreland buffer zone creates or restores the ecological habitat and benefits lost by traditional suburban landscaping. Simply not mowing within the buffer zone does wonders to restore some of the shoreland’s natural function.

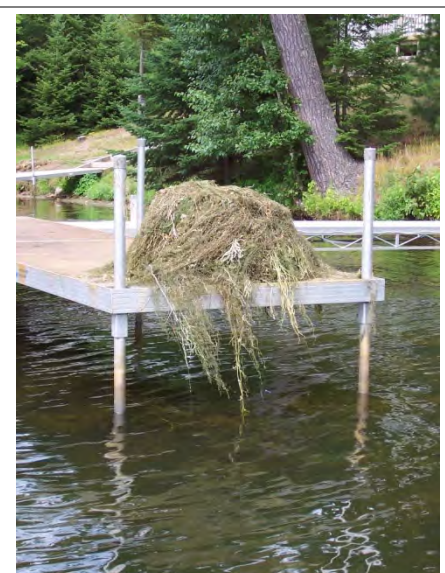
Manual removal or hand-harvesting of aquatic invasive species has gained favor in recent years as an alternative to herbicide control programs. Professional hand-harvesting firms can be contracted for these efforts and can either use basic snorkeling or scuba divers, whereas others might employ the use of a Diver Assisted Suction Harvest (DASH) which involves divers removing plants and feeding them into a suctioned hose for delivery to the deck of the harvesting vessel. The DASH methodology is considered a form of mechanical harvesting and thus requires a WDNR approved permit. DASH is thought to be more efficient in removing target plants than divers alone and is believed to limit fragmentation during the harvesting process.

Photograph 3.4-2. Example of aquatic plants that have been removed manually.

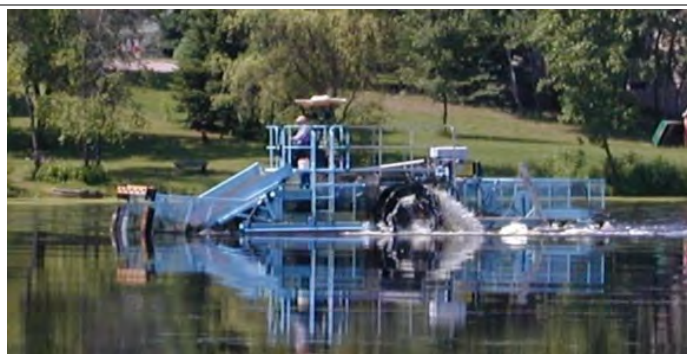
Aquatic plant harvesting is frequently used in Wisconsin and involves the cutting and removal of plants much like mowing and bagging a lawn. Harvesters are produced in many sizes that can cut to depths ranging from 3 to 6 feet with cutting widths of 4 to 10 feet. Plant harvesting speeds vary with the size of the harvester, density and types of plants, and the distance to the off-loading area. Equipment requirements

Photograph 3.4-3. Mechanical harvester.

do not end with the harvester. In addition to the harvester, a shore-conveyor would be required to transfer plant material from the harvester to a dump truck for transport to a landfill or compost site. Furthermore, if off-loading sites are limited and/or the lake is large, a transport barge may be needed to move the harvested plants from the harvester to the shore in order to cut back on the time that the harvester spends traveling to the shore conveyor. Some lake organizations contract to have nuisance plants harvested, while others choose to purchase their own equipment. If the latter route is chosen, it is especially important for the lake group to be very organized and realize that there is a great deal of work and expense involved with the purchase, operation, maintenance, and storage of an aquatic plant harvester. In either case, planning is very important to minimize environmental effects and maximize benefits.

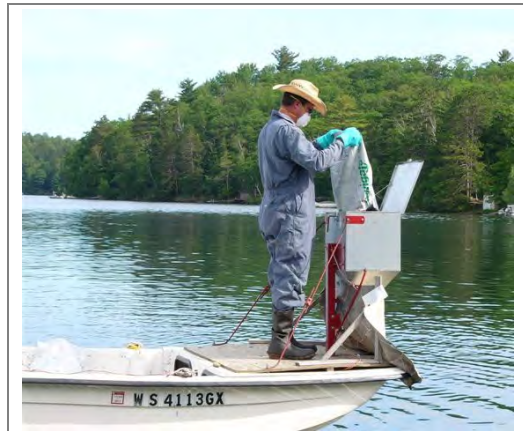
The use of herbicides to control aquatic plants and algae is a technique that is widely used by lake managers. Traditionally, herbicides were used to control nuisance levels of aquatic plants and algae that interfere with navigation and recreation. While this practice still takes place in many parts of Wisconsin, the use of herbicides to control aquatic invasive species is becoming more prevalent. Resource managers employ strategic management techniques towards aquatic invasive species, with the objective of reducing the target plant's population over time; and an overarching goal of attaining long-term ecological restoration. For submergent vegetation, this largely consists of implementing control strategies early in the growing season; either as spatially-targeted, small-scale spot treatments or low-dose, large-scale (whole lake) treatments. Treatments occurring roughly each year before June 1 and/or when water temperatures are below 60°F can be less impactful to many native plants, which have not emerged yet at this time of year. Emergent species are targeted with foliar applications at strategic times of the year when the target plant is more likely to absorb the herbicide.

Photograph 3.4-4. Granular herbicide application.

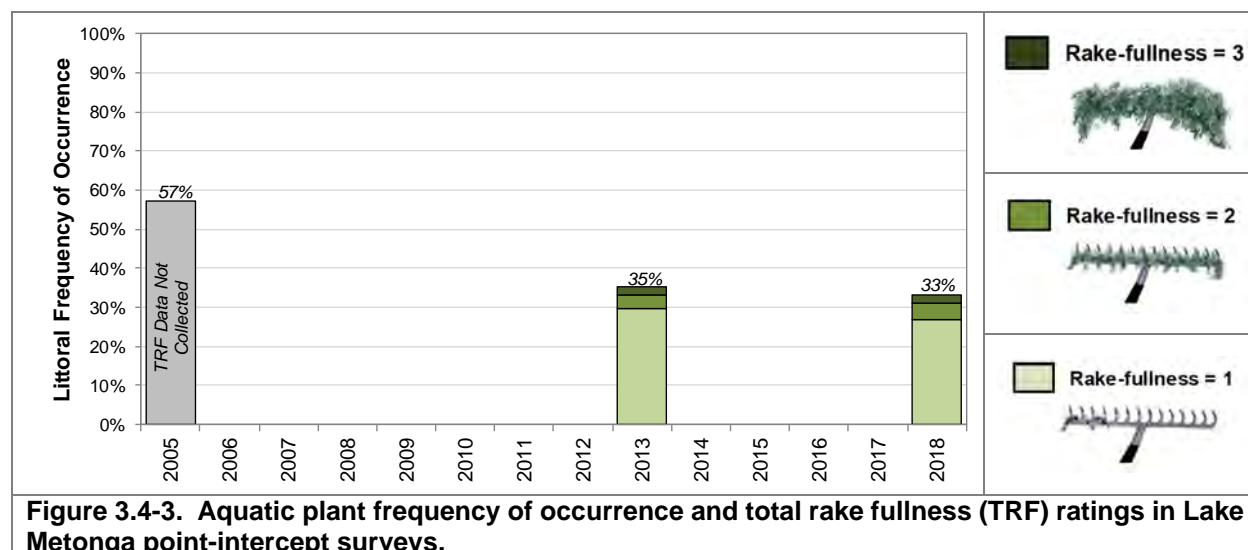
Figure 3.4-3. Aquatic plant frequency of occurrence and total rake fullness (TRF) ratings in Lake Metonga point-intercept surveys.

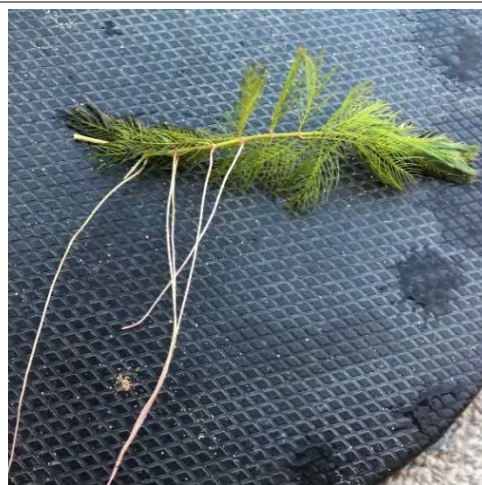
Photograph 3.4-12. EWM fragment with adventitious roots. Photo credit Onterra.

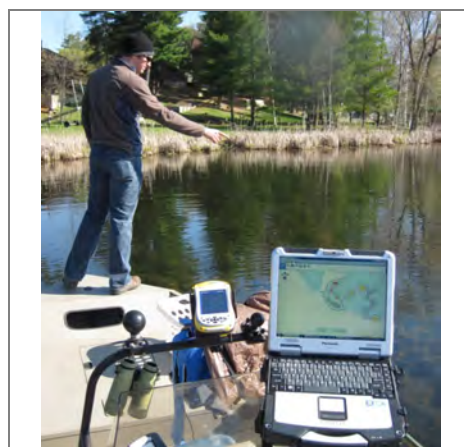
While the point-intercept survey is a valuable tool to understand the overall plant population of a lake, it does not offer a full account (census) of where a particular species exists in the lake. During the AIS mapping surveys, the entire littoral area of the lake was surveyed through visual observations from the boat (Photograph 3.4-13). Field crews supplemented the visual survey by deploying a submersible camera along with periodically doing rake tows. The EWM population is mapped using sub-meter GPS technology by using either 1) point-based or 2) area-based methodologies. Large colonies >40 feet in diameter are mapped using polygons (areas) and were qualitatively attributed a density rating based upon a five-tiered scale from *highly scattered* to *surface matting*. Point-based

Photograph 3.4-13. EWM mapping survey. Photo credit Onterra.

techniques were applied to EWM locations that were considered as *small plant colonies* (<40 feet in diameter), *clumps of plants*, or *single or few plants*.

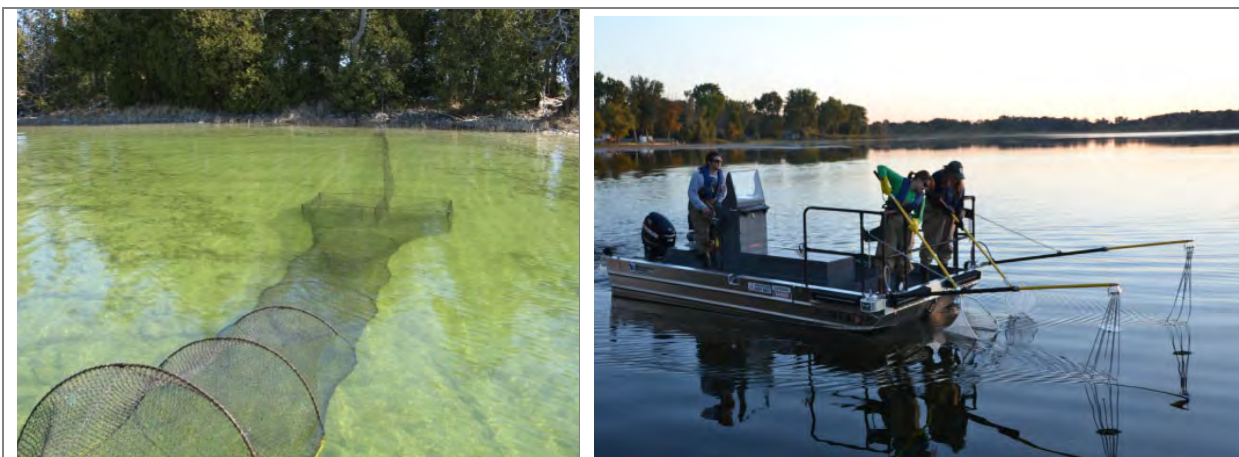
Photograph 3.6-1. Fyke net positioned in the littoral zone of a Wisconsin Lake (left) and an electroshocking boat (right).

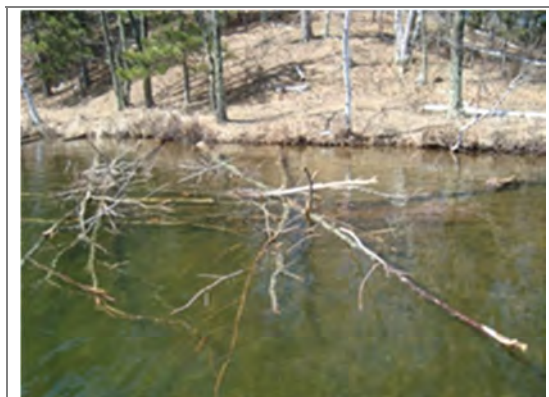
As discussed in the Shoreland Condition Section, the presence of coarse woody habitat is important for many stages of a fish's life cycle, including nesting or spawning, escaping predation as a juvenile, and hunting insects or smaller fish as an adult. Unfortunately, as development has increased on Wisconsin lake shorelines in the past century, this beneficial habitat has often been the first to be removed from the natural shoreland zone. Leaving these shoreland zones barren of coarse woody habitat can lead to decreased abundances and slower growth rates in fish (Sass 2006). A fall 2018 survey documented 35 pieces of coarse woody along the shores of Lake Metonga, resulting in a ratio of approximately 4 pieces per mile of shoreline. Fisheries Biologists do not suggest a specific number of fish sticks for a lake but rather highly encourage their installation wherever possible. To learn how Lake Metonga's coarse woody habitat is compared to other lakes in its region please refer to section 3.3.

Photograph 3.6-3. Fish Stick Example.
(Photo courtesy of WDNR 2013).

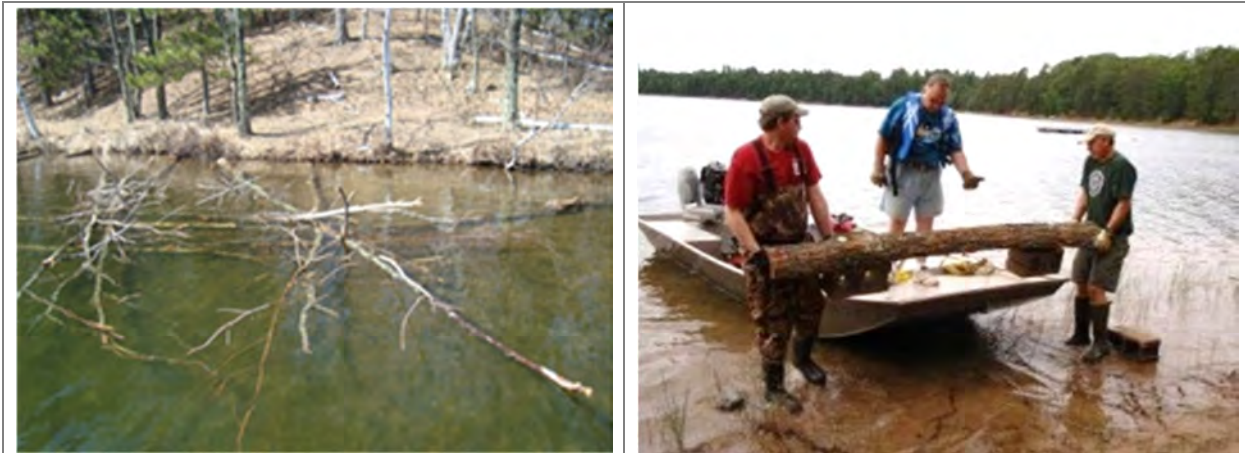
Photograph 3.6-4. Examples of fish sticks (left) and half-log habitat structures. (Photos by WDNR)
